**SURVEY OF
MUD WALLS
IN
WHITTLESEY
AND
EASTREA**

2016 / 2017

**Whittlesey
Mud Walls
Group**

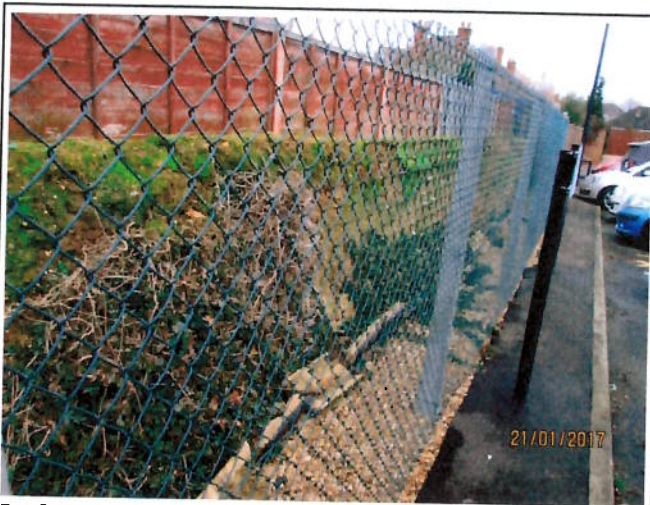
Left L/H end of wall

Condition	Coping missing completely, moss and ivy prevalent.
Comments	Wall in poor condition, but could be rebuilt to a decent standard.

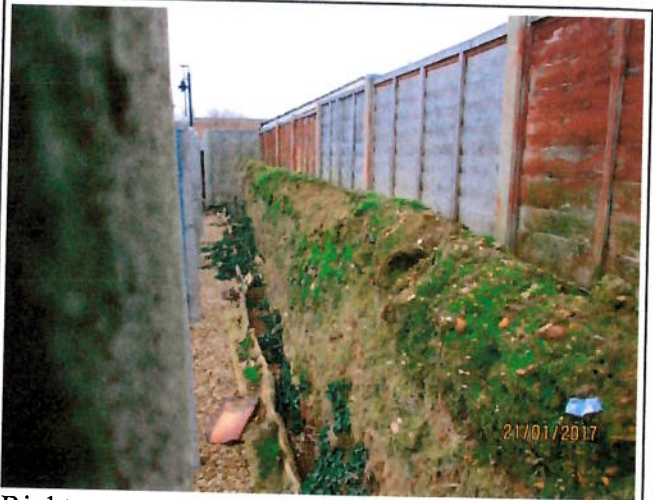
Right R/H end of wall

Condition	Coping missing completely, moss and ivy prevalent.
Comments	Wall in poor condition, but could be rebuilt to a decent standard.

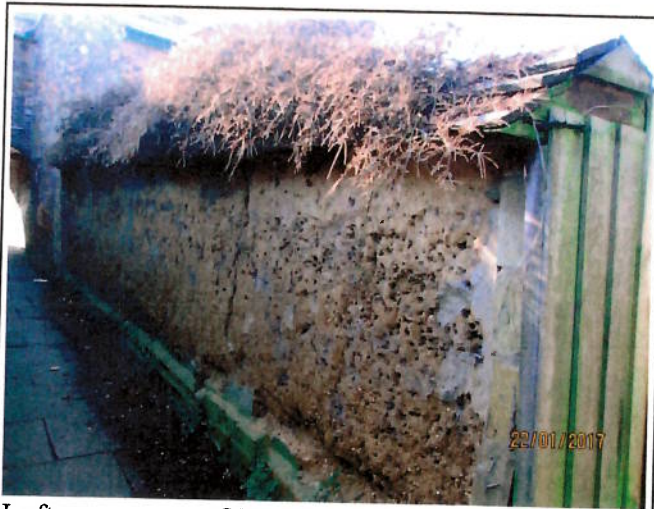
Left **Old Crown Lane**

Length (ft) (m)	25ft 3in 7m 70cm	Width (ft) (m)	1ft 7in 50cm	Height (ft) (m)	6ft 7in 2m 01cm	
Height (ft) (m)	Footing	6in 15cm	Mud Work	5ft 4in 1m 63cm	Coping	9in 23cm
Condition	Erosion of mud at footing level. Cotoneaster causing rotting of wooden coping.					
Comments	Cotoneaster should be removed and coping replacing.

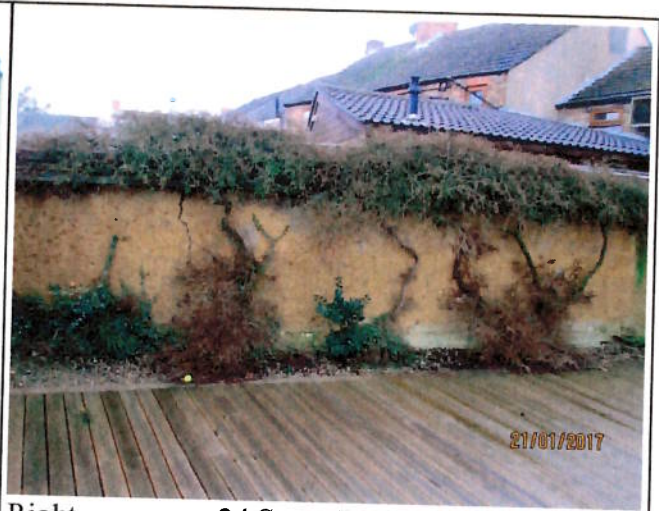
Right **24 Syers Lane**

Length (ft) (m)	25ft 3in 7m 70cm	Width (ft) (m)	1ft 7in 50cm	Height (ft) (m)	6ft 10in 2m 08cm	
Height (ft) (m)	Footing	9in 23cm	Mud Work	5ft 4in 1m 63cm	Coping	9in 23cm
Condition	One vertical crack in mud, wall and coping covered in Cotoneaster.					
Comments	Footing repaired with cement. Evidence of bee activity.

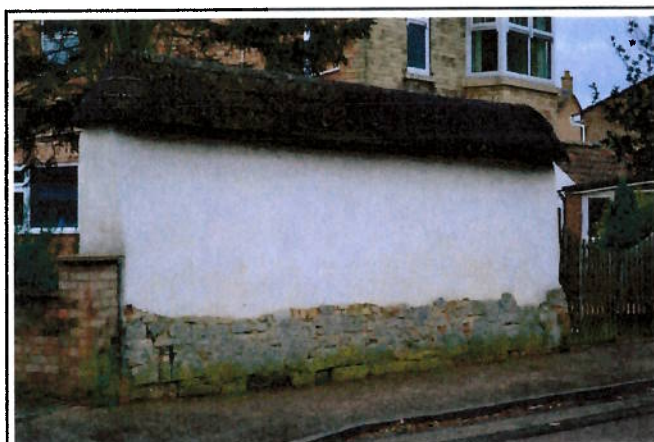
Left **Roadside**

Length (ft) (m)	22ft 10in 6m 94cm	Width (ft) (m)	2ft 2in - 1ft 7in 66cm - 48cm	Height (ft) (m)	9ft 5in 2m 87cm
Height (ft) (m)	Footing	2ft 2in 66cm	Mud Work	5ft 3in 1m 60cm	Coping 2ft 61cm
Condition	Very good.				
Comments	Small hole in render should be repaired.

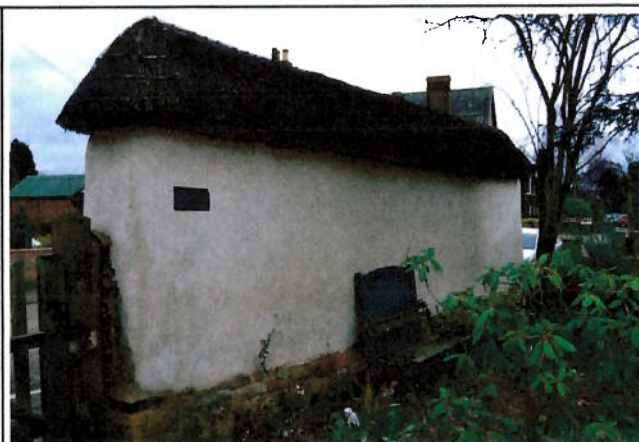
Right **Inside Garden**

Length (ft) (m)	22ft 10in 6m 94cm	Width (ft) (m)	2ft 2in - 1ft 7in 66cm - 48cm	Height (ft) (m)	8ft 7in 2m 62cm
Height (ft) (m)	Footing	1ft 4in 41cm	Mud Work	5ft 3in 1m 60cm	Coping 2ft 61cm
Condition	Very good.				
Comments	Laburnum tree could cause future problems.

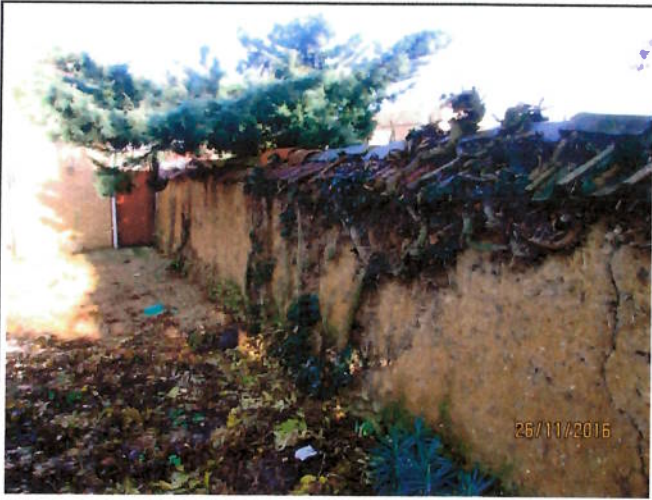
Left **6c Delph St**

Condition	Generally good.
Comments	Attention required to tiled coping. Ivy and vegetation should be removed. Soil level requires lowering.

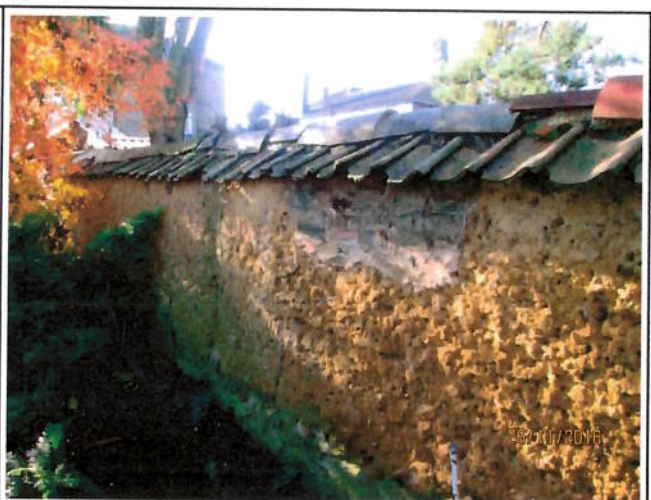
Right **4 Delph St**

Condition	Generally good.
Comments	Attention required to tiled coping. Evidence of bee activity.

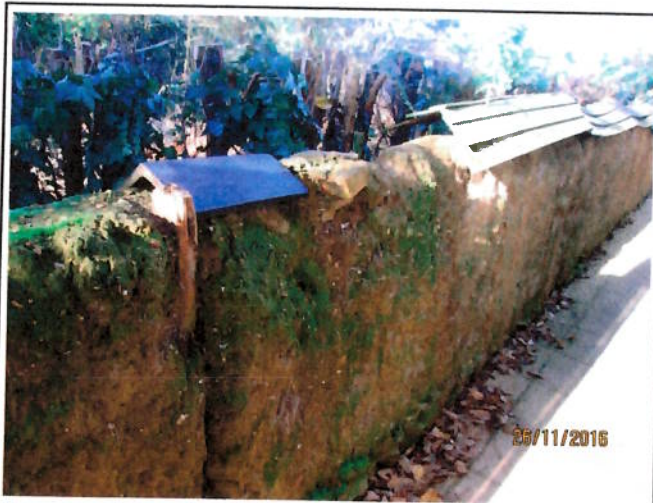
Left **6b Delph St**

Condition	Very poor. Coping damaged or missing. Mud erosion caused by leaking gutter.
Comments	Paving slabs higher than footing level.

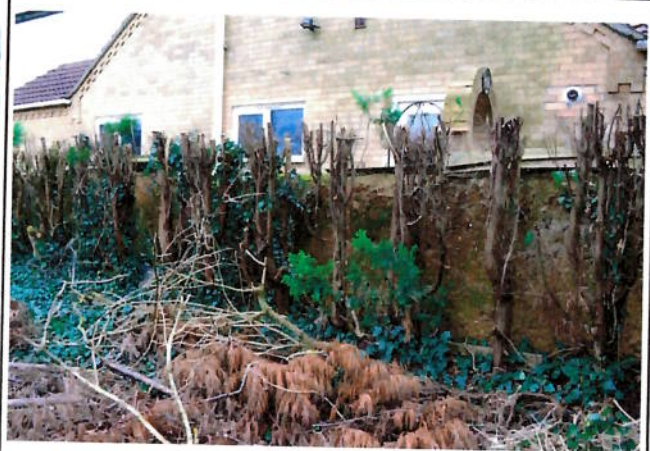
Right **8 Delph St**

Condition	Very poor. Coping damaged or missing.
Comments	Conifers have been cut back and roots should rot away.

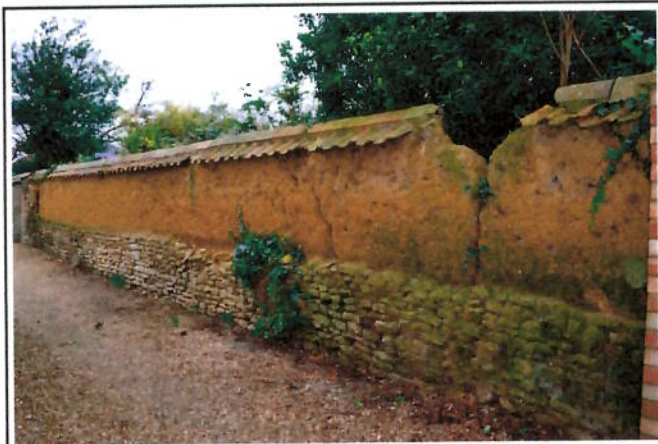
Left **Delph Court**

Condition	Average but with major damage.
Comments	Gap caused by tree damage. Broken tiles should be replaced. Evidence of bee activity.

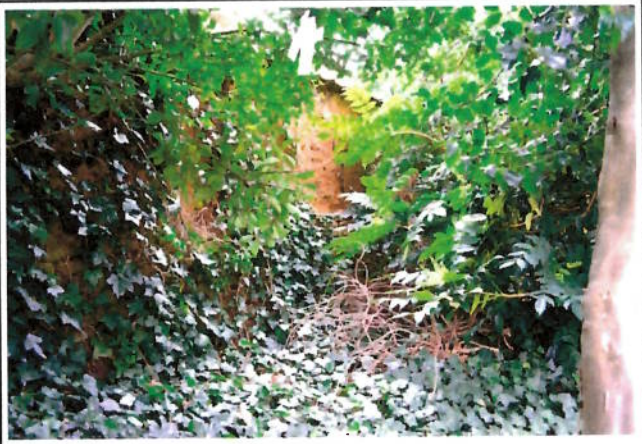
Right **8 Delph St**

Condition	Unsure of condition as overgrown with vegetation.
Comments	Vegetation should be cleared to assess wall condition.

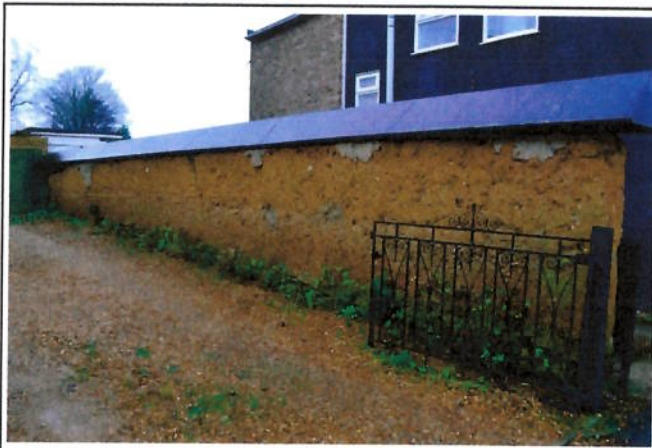
Left **87 Gracious St**

Condition	Reasonable.
Comments	Vegetation should be controlled.

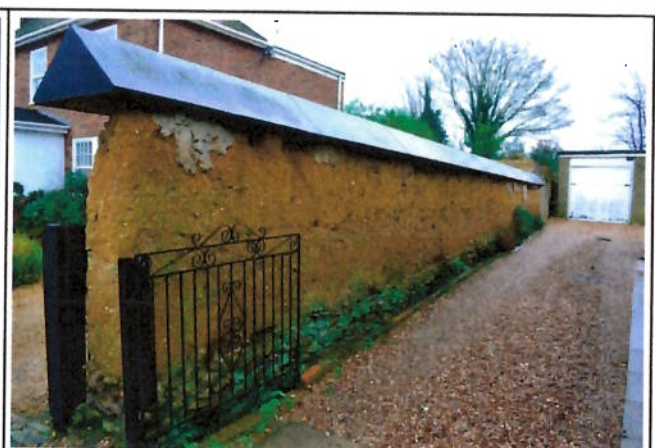
Right **89 Gracious St**

Condition	Reasonable.
Comments	Some erosion above footing.

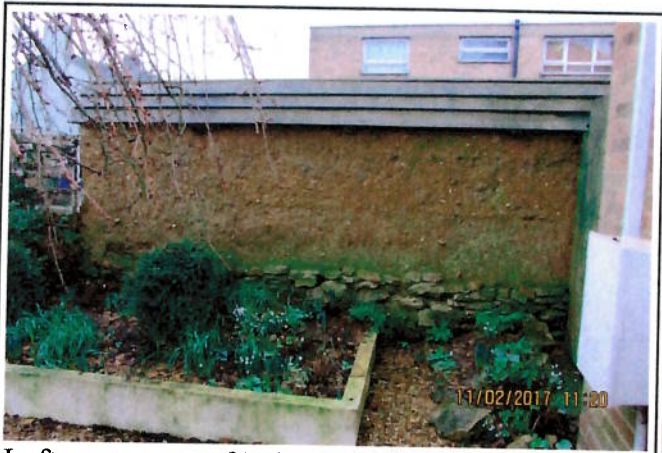
Left **87 Gracious St**

Length (ft) (m)	36ft 10in 11m 23cm	Width (ft) (m)	1ft 4in 41cm	Height (ft) (m)	7ft 5in 2m 26cm
Height (ft) (m)	Footing 2ft 3in 69cm	Mud Work (Exposed)	4ft 1m 22cm	Coping	1ft 2in 36cm
Condition	Good.				
Comments	Holes in footings could be pointed with lime mortar.

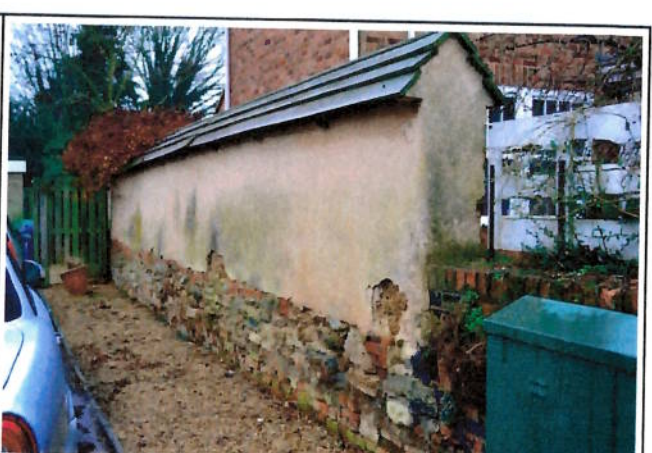
Right **St Mary's House**

Length (ft) (m)	36ft 10in 11m 23cm	Width (ft) (m)	1ft 4in 41cm	Height (ft) (m)	6ft 3in 1m 90cm
Height (ft) (m)	Footing 1ft 1in 33cm	Mud Work (Rendered)	4ft 1m 22cm	Coping	1ft 2in 36cm
Condition	Fairly good.				
Comments	Holes in render require attention.

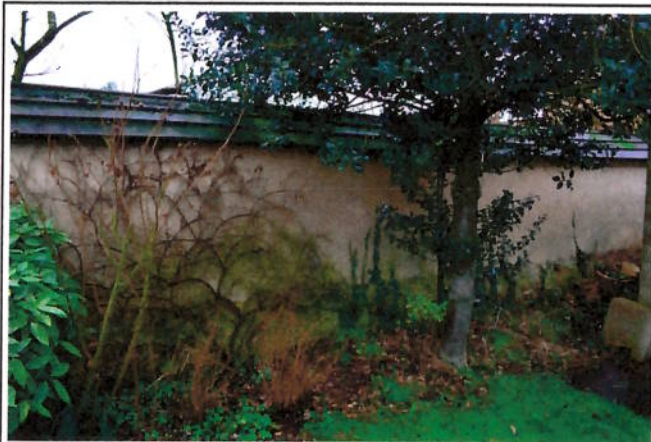
Left **St Mary's House**

Length (ft) (m)	40ft 6in 12m 35cm	Width (ft) (m)	1ft 30cm	Height (ft) (m)	7ft 5in 2m 26cm	
Height (ft) (m)	Footing	1ft 4in 41cm	Mud Work (Rendered)	4ft 6in 1m 37cm	Coping	1ft 7in 48cm
Condition	Good.					
Comments	Vegetation should be controlled.

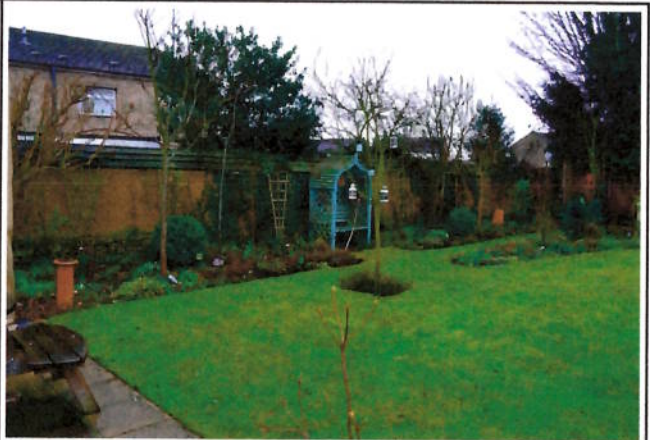
Right **87 Gracious St**

Length (ft) (m)	72ft 21m 96cm	Width (ft) (m)	1ft 30cm	Height (ft) (m)	7ft 5in 2m 26cm	
Height (ft) (m)	Footing	1ft 4in 41cm	Mud Work (Exposed)	4ft 6in 1m 37cm	Coping	1ft 7in 48cm
Condition	Good.					
Comments	Vegetation should be controlled.

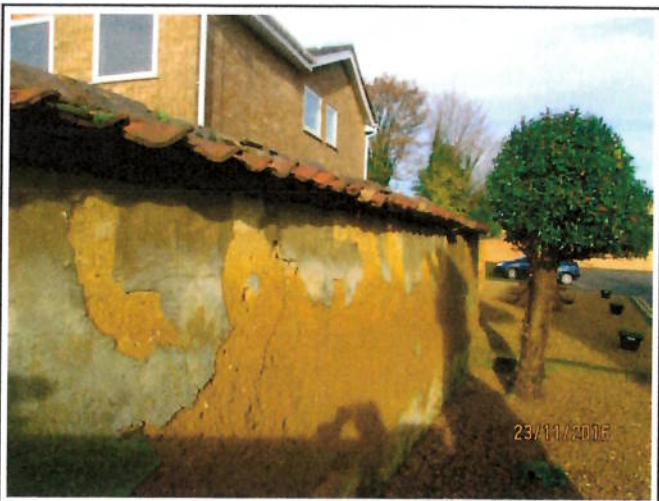
Left **Conservative Club**

Length (ft) (m)	20ft 5in 6m 23cm	Width (ft) (m)	1ft 7in 48cm	Height (ft) (m)	7ft 2m 13cm
Height (ft) (m)	Footing	1ft 2in 36cm	Mud Work	4ft 10in 1m 47cm	Coping 1ft 30cm
Condition	Reasonable, showing original limewash.				
Comments	Evidence of bee activity. We welcome the planned restoration.

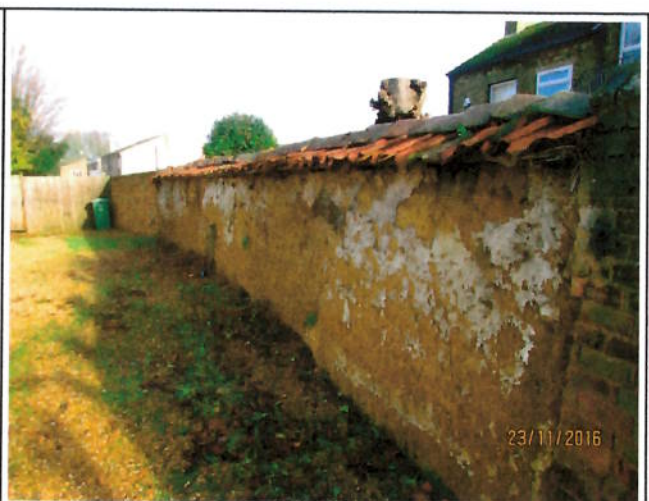
Right **36 Whitmore St**

Length (ft) (m)	20ft 5in 6m 23cm	Width (ft) (m)	1ft 7in 48cm	Height (ft) (m)	5ft 10in 1m 78cm
Height (ft) (m)	Footing	Not visible	Mud Work	4ft 10in 1m 47cm	Coping 1ft 30cm
Condition	Soil level above footings. Erosion of mud caused by usage of water tap.				
Comments	Soil level requires lowering and water pipe should be removed.

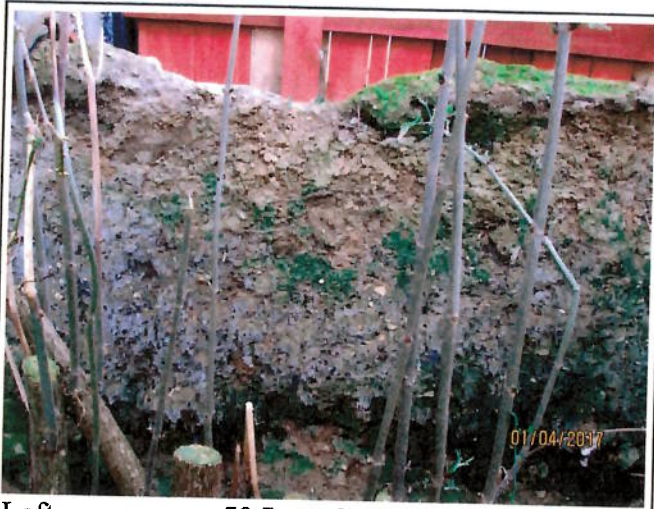
Left **50 Low Cross**

Condition	Very poor. Coping missing.
Comments	Surrounded by shrubs, trees and vegetation.

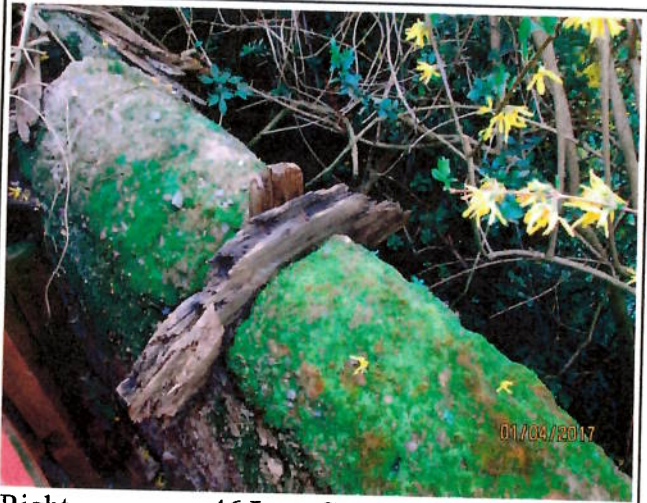
Right **46 Low Cross**

Condition	Very poor. Coping missing.
Comments	Surrounded by shrubs, trees and vegetation.

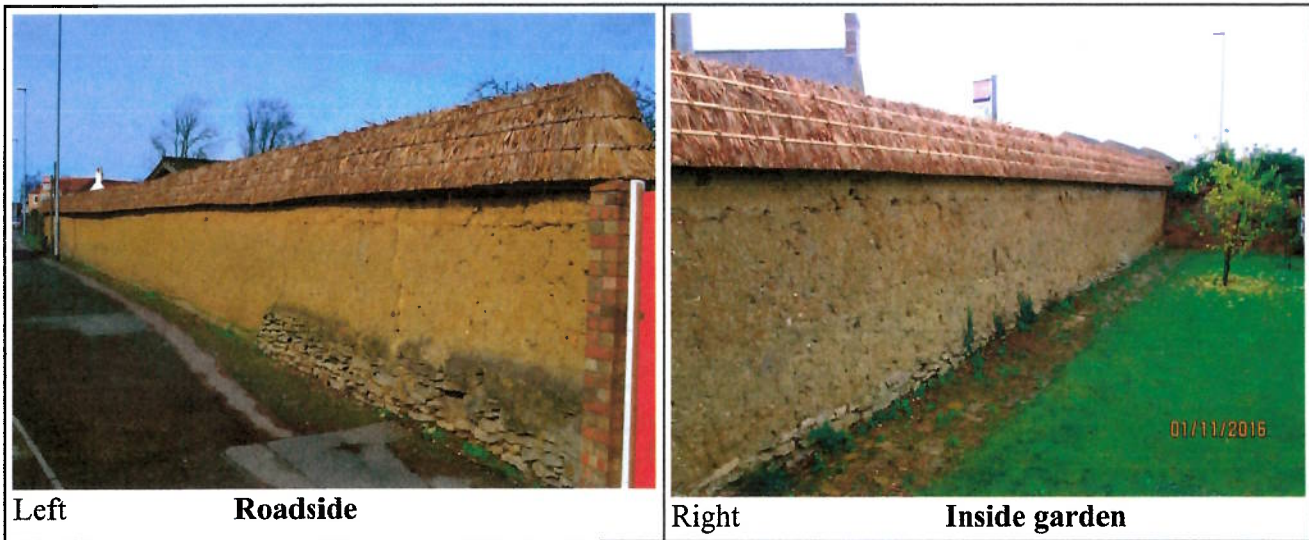
Left	Roadside	Right	Inside garden
------	----------	-------	---------------

Condition	Good, with some erosion above footings.
Comments	Erosion of mud caused by road splash. Some stones missing from footings.

Condition	Very good.
Comments	Vegetation at far end should be controlled.

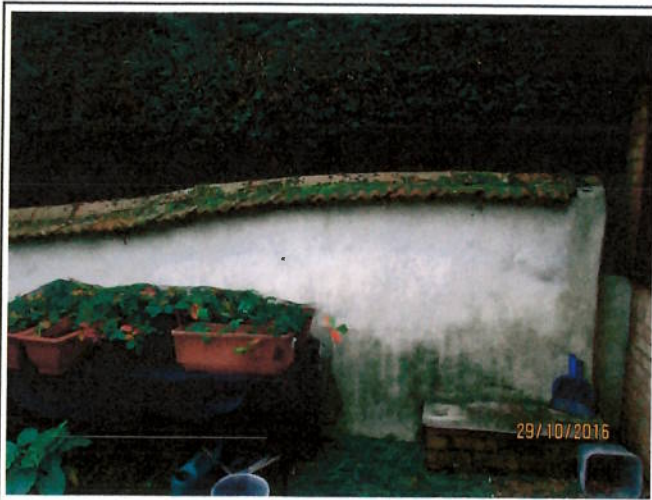
Left **2 Willow Close**

Condition	Good. Soil level too high.
Comments	Rendered footing and mud. Soil level requires lowering.

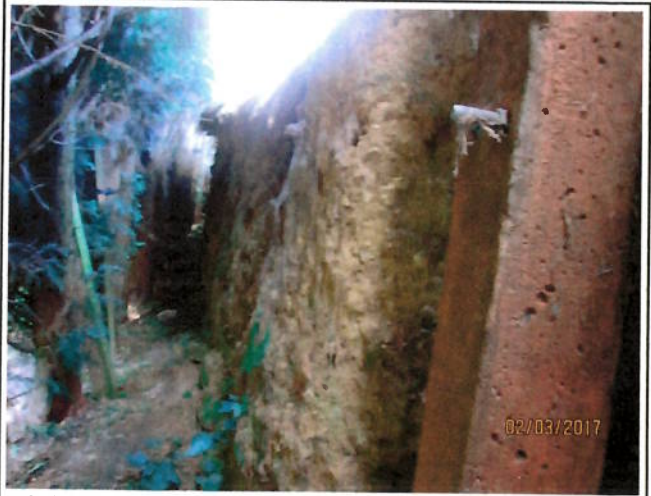
Right **3 Willow Close**

Condition	Reasonable. Soil level too high. Tile missing causing wall erosion.
Comments	Exposed mud. Soil level requires lowering.

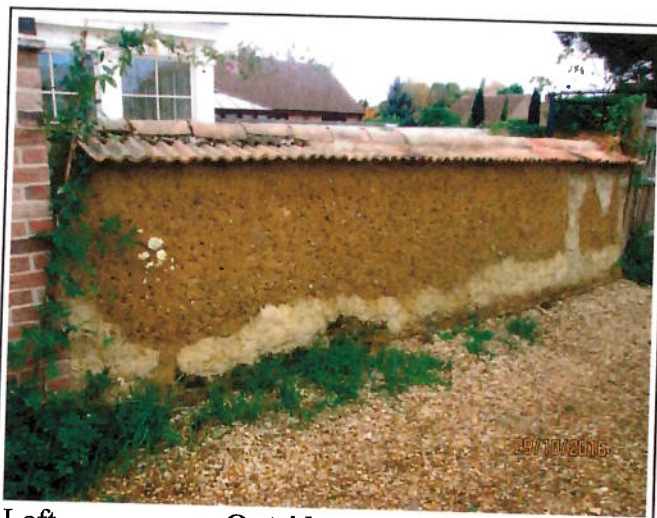
Left **Outside property**

Condition	Good.
Comments	Recent repairs to base of wall.

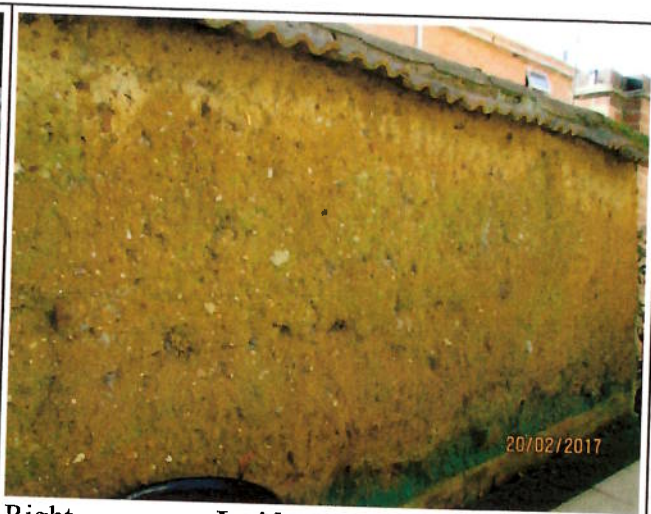
Right **Inside garden**

Condition	Fairly good.
Comments	Erosion to base of wall caused by damp.

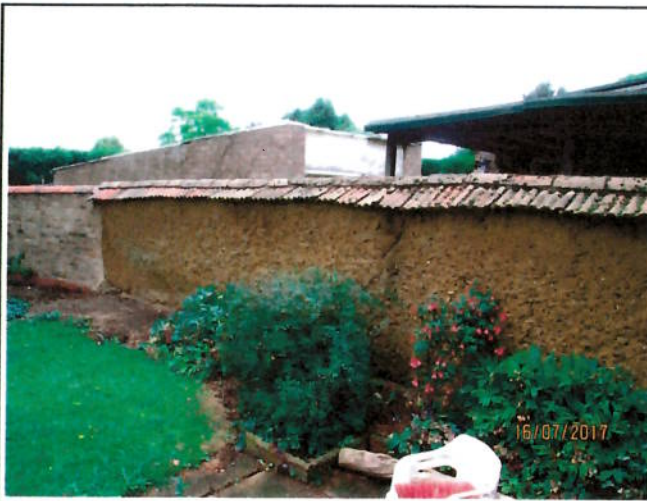
Left **9 Horsegate**

Condition	Good. Footings part concrete. Soil level too high.
Comments	Soil level requires lowering. Some tiles require replacing.

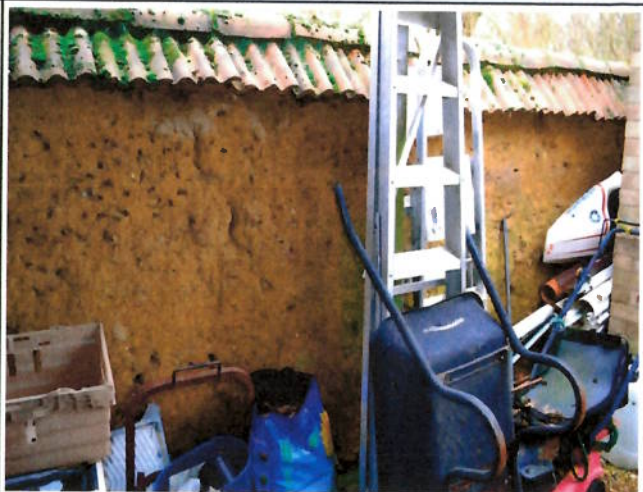
Right **13 Horsegate**

Condition	Good.
Comments	Items stored against the wall can cause damp.

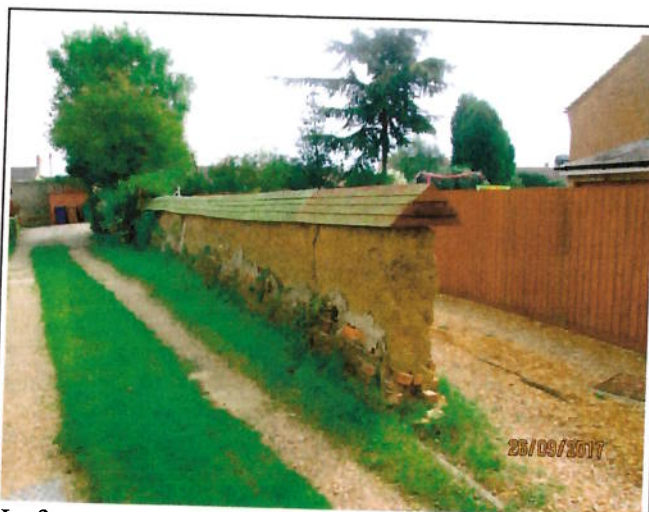
Left **Wades Yard**

Condition	Fair.
Comments	Wall end requires restoring. Wooden coping requires attention at far end.

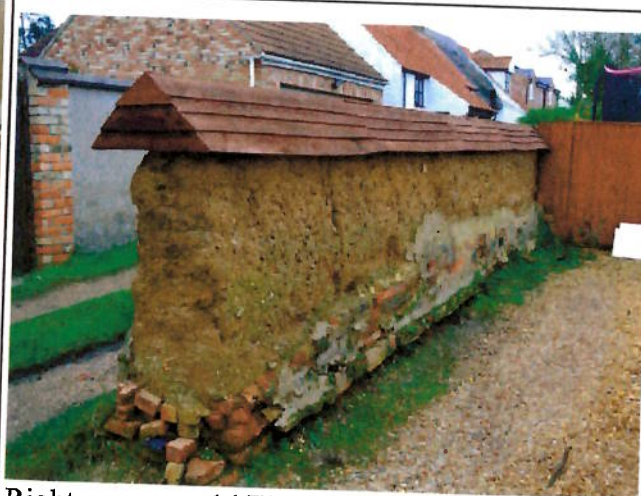
Right **14 Horsegate**

Condition	Fair.
Comments	Wall end requires restoring. Wooden coping requires attention at far end.

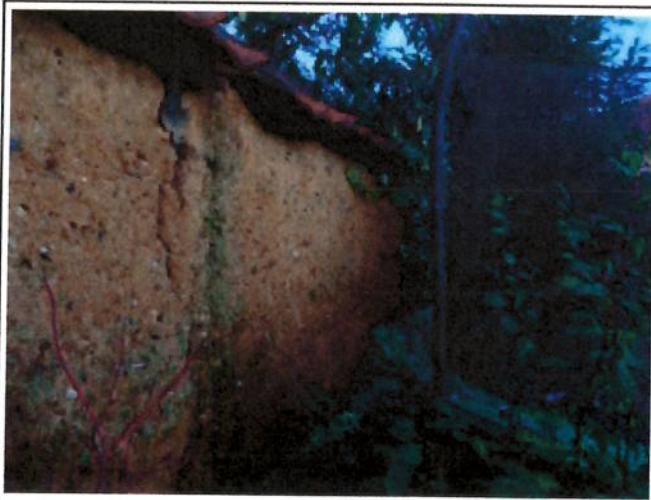
Left **8 Horsegate**

Length (ft) (m)	38ft 11m 59cm	Width (ft) (m)	1ft 2in 36cm	Height (ft) (m)	6ft 6in 1m 98cm
Height (ft)	Footing 6in 15cm	Mud Work	4ft 10in 1m 48cm	Coping	1ft 2in 36cm
Condition	Good. Some tiles require replacing.				
Comments	Vegetation should be removed.

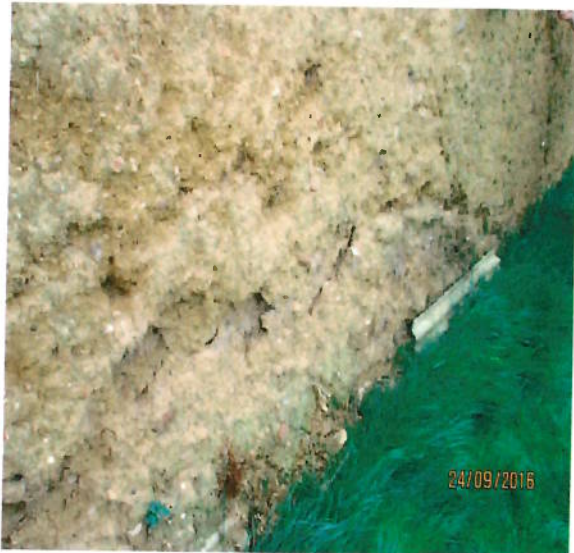
Picture 1

Picture 1, shows imminent collapse caused by absorption of dampness from the high soil level above the footings.

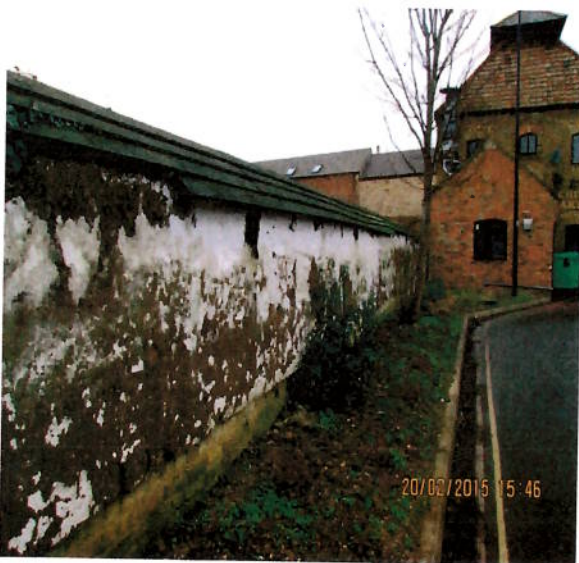
Picture 3

Picture 3, shows a badly finished wall, painted in a non-breathable paint. The paint is shedding due to moisture trying to get out of the wall. The missing wooden coping is responsible for the main ingress of water.
