**SURVEY OF
MUD WALLS
IN
WHITTLESEY
AND
EASTREA**

2016 / 2017

**Whittlesey
Mud Walls
Group**

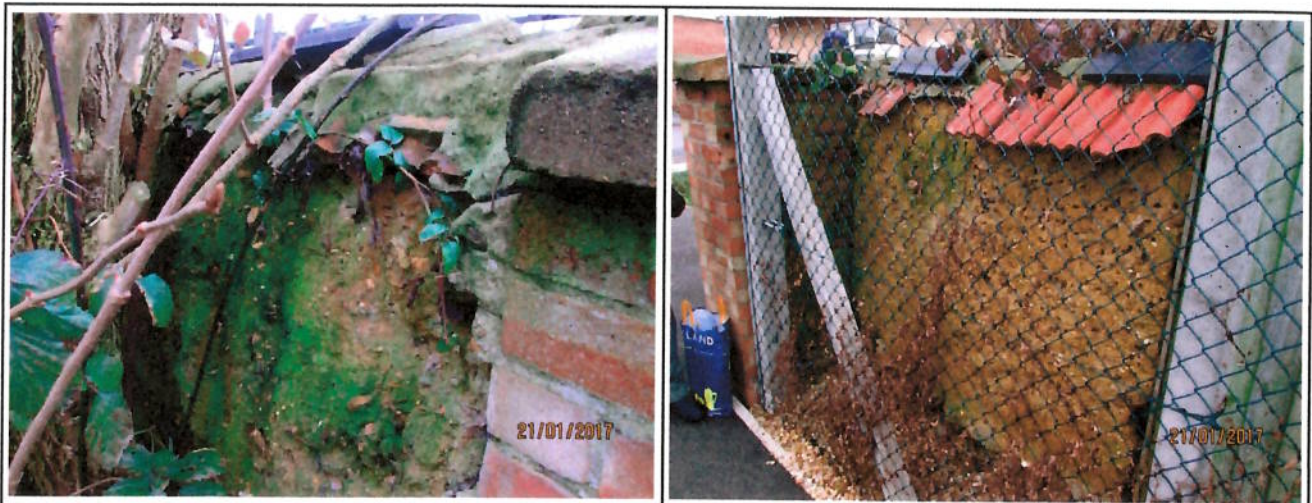
Location	Blunts Lane / Grosvenor Rd bus stop
----------	--

Condition	Pan tiles and Ridge tiles missing, causing erosion of wall.
Comments	Elder bush caused damage to tiles, and should be removed.

Condition	Pan tiles and Ridge tiles missing. Some erosion.
Comments	Evidence of bee activity.

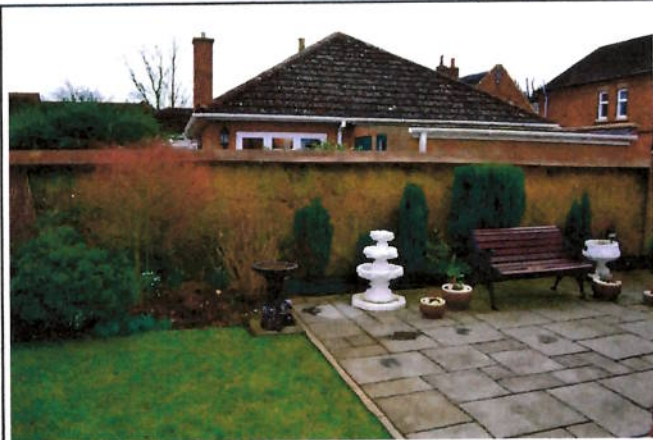
7 Arnolds Lane

Condition	Soil level above footing level.
Comments	Wooden coping should have more overhang. Soil level requires lowering.

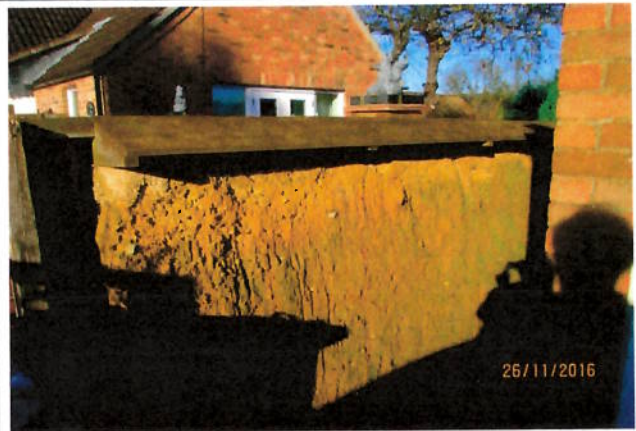
25 Arnolds Lane

Condition	Mud erosion caused by wooden coping too short.
Comments	Paving slabs causing damp in base of wall.

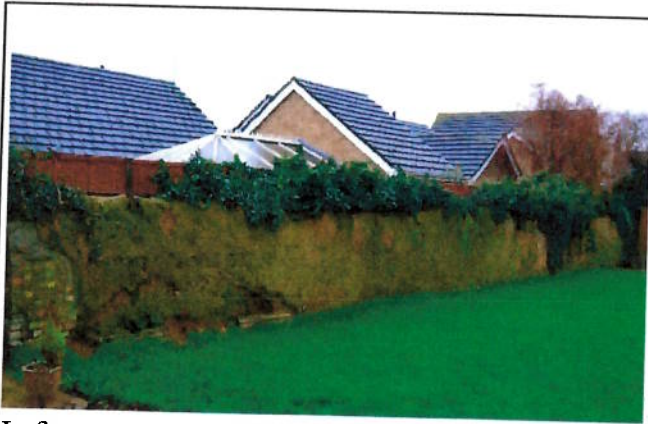
Left **27c Windmill St**

Length (ft) (m)	77ft 6in 23m 64cm	Width (ft) (m)	1ft 3in 38cm	Height (ft) (m)	5ft 11in 1m 80cm
Height (ft) (m)	Footing 8in 20cm	Mud Work	5ft 3in 1m 60cm	Coping	Nil
Condition	Poor, with some subsidence. Coping missing. Soil level too high.				
Comments	Vegetation should be cut back. Soil level should be lowered.

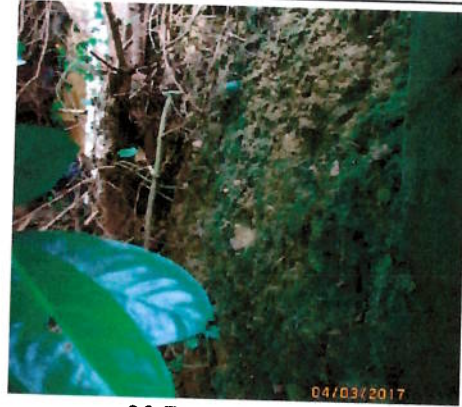
Right **20 Low Cross**

Length (ft) (m)	9ft 2m 75cm	Width (ft) (m)	1ft 3in 38cm	Height (ft) (m)	5ft 7in 1m 70cm
Height (ft) (m)	Footing 8in 20cm	Mud Work	4ft 11in 1m 52cm	Coping	Nil
Condition	Coping missing. Wall obscured by vegetation.				
Comments	Vegetation should be cut back.

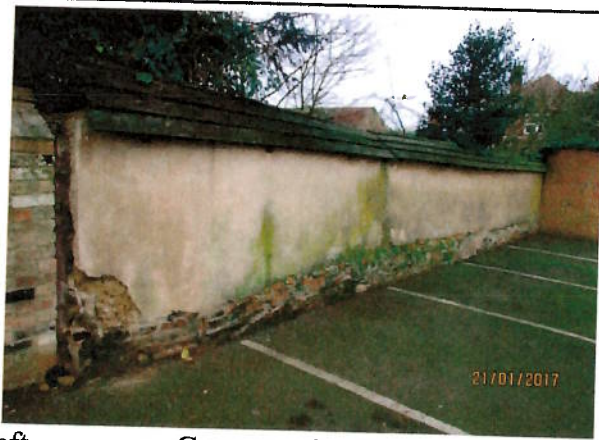
Left **Conservative Club**

Length (ft) (m)	36ft 6in 11m 13cm	Width (ft) (m)	1ft 30cm	Height (ft) (m)	6ft 10in 2m 09cm	
Height (ft) (m)	Footing	1ft 7in 48cm	Mud Work (Rendered)	3ft 11in 1m 21cm	Coping	1ft 4in 41cm
Condition	Gaps in joints on coping causing water ingress.					
Comments	Render requires repair.

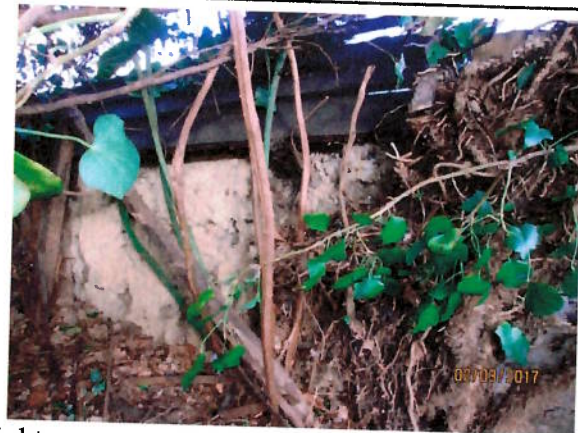
Right **36 Whitmore St**

Length (ft) (m)	5ft 1m 53cm	Width (ft) (m)	1ft 30cm	Height (ft) (m)	4ft 4in 1m 32cm	
Height (ft) (m)	Footing	Not visible	Mud Work (Exposed)	3ft 91cm	Coping	1ft 4in 41cm
Condition	Reasonable. This section has been limewashed.					
Comments	Vegetation should be removed, and soil level requires lowering.

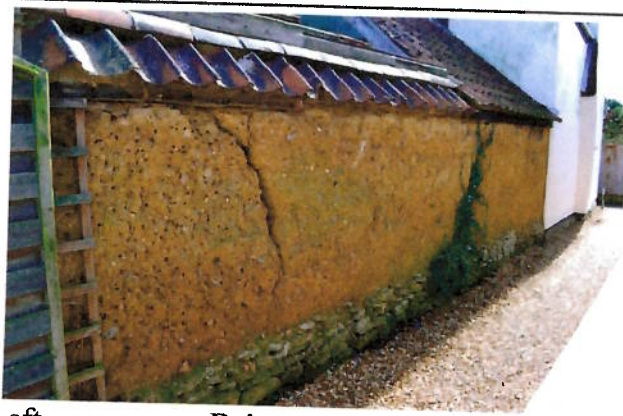
Driveway

Length (ft) (m)	25ft 8in 7m 83cm	Width (ft) (m)	1ft 2in 36cm	Height (ft) (m)	7ft 6in 2m 29cm	
Height (ft) (m)	Footing	1ft 6in 46cm	Mud Work	4ft 4in 1m 32cm	Bricks Coping	4in / 10cm 1ft4in / 41cm
Condition	Fairly good.					
Comments	Crack in mud requires repair. Ivy should be removed. Evidence of bee activity.

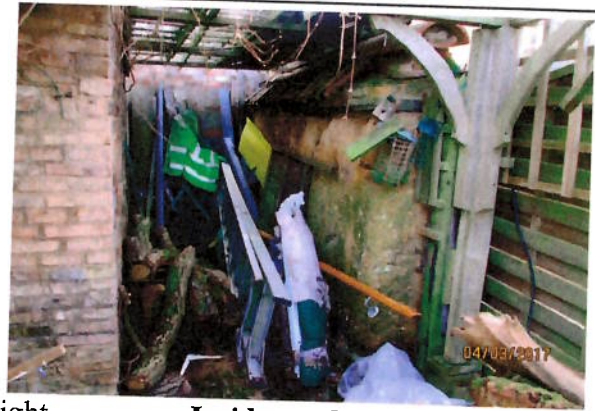
Inside yard

Length (ft) (m)	12ft 3m 66cm	Width (ft) (m)	1ft 2in 36cm	Height (ft) (m)	6ft 10in 2m 08cm	
Height (ft) (m)	Footing	10in 25cm	Mud Work	4ft 4in 1m 32cm	Bricks Coping	4in / 10cm 1ft4in / 41cm
Condition	Fairly good.					
Comments	Damage to coping. Crack in mud requires repair. Some footings missing.

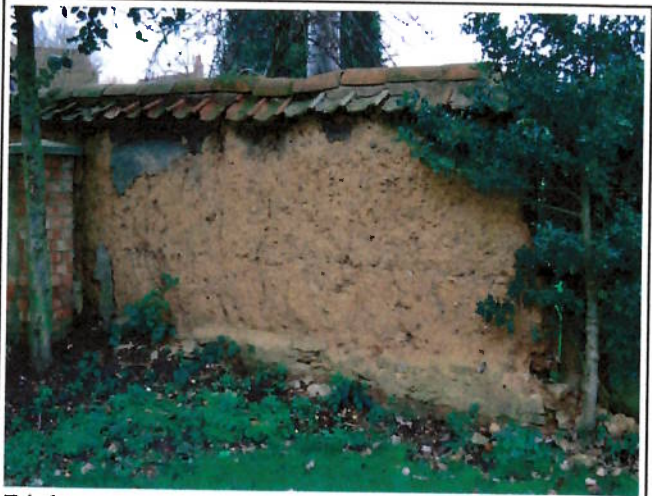
Right **14 Horsegate**

Length (ft) (m)	11ft 6in 3m 51cm	Width (ft) (m)	1ft 2in 36cm	Height (ft) (m)	6ft 6in 1m 98cm
Height (ft)	Footing 6in 15cm	Mud Work	4ft 10in 1m 48cm	Coping	1ft 2in 36cm
Condition	Good. Some tiles require replacing.				
Comments	Vegetation should be removed. End of wall requires restoration.

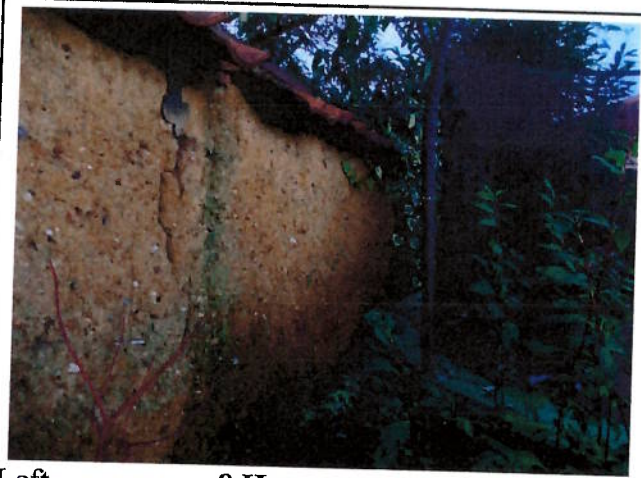
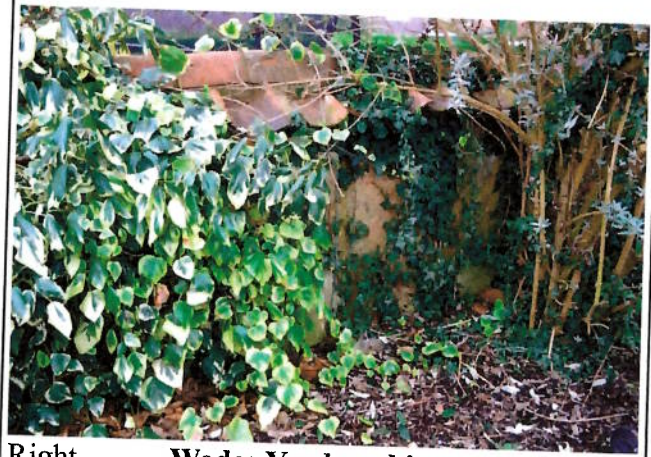
Location **8 Horsegate / Wades Yard parking area**

Length (ft) (m)	26ft 6in 8m 08cm	Width (ft) (m)	1ft 2in 36cm	Height (ft) (m)	4ft 10in 1m 48cm	
Height (ft) (m)	Footing	Not visible	Mud Work	3ft 8in(visible) 1m 12cm	Coping	1ft 2in 36cm
Condition	Fair. Vegetation covering most of wall.					
Comments	Soil level next to wall requires lowering. Vegetation should be removed. The parking area is higher than the gardens of 8 and 14, so the lower part of the wall and footings, a depth of 20in / 50cm, is not visible on this site.

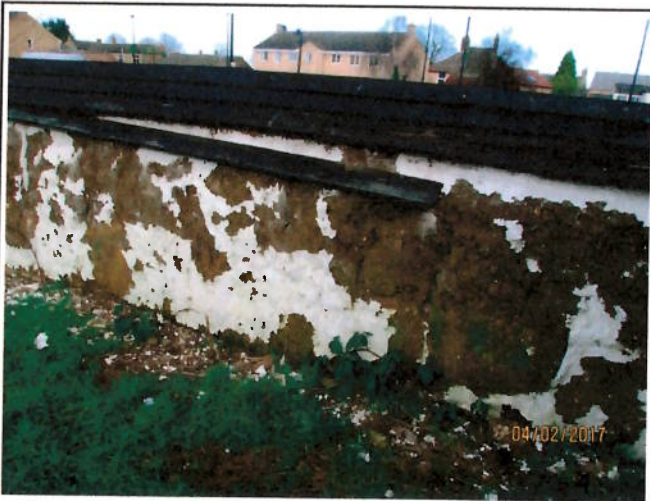
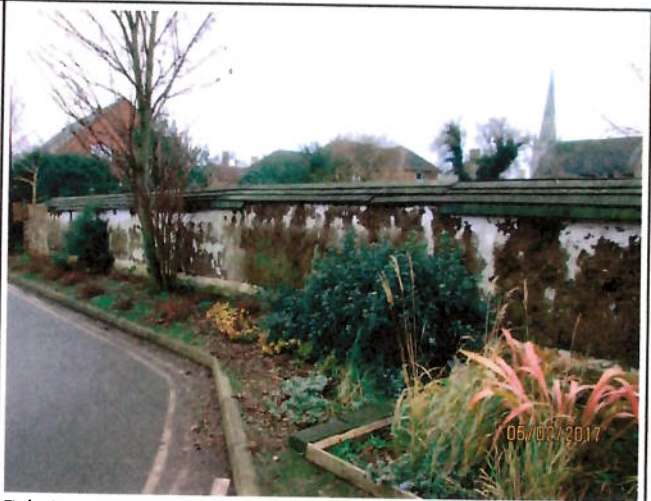
Location **Black Bull Public House / Queen St car park**

Length (ft) (m)	60ft 18m 47cm	Width (ft) (m)	1ft 8in 51cm	Height (ft) (m)	6ft 2in 1m 88cm	
Height (ft) (m)	Footing	1ft 30cm	Mud Work	3ft 10in 1m 17cm	Coping	1ft 4in 41cm
Condition	Rendering and coping poor.					
Comments	We welcome the planned restoration.

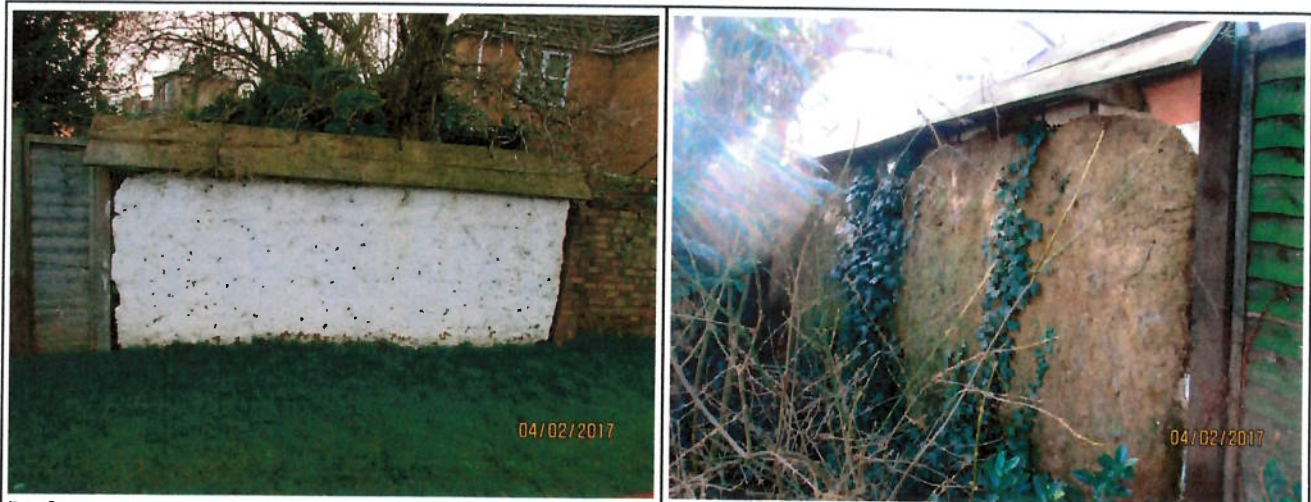
Location **Black Bull Public House / 7c Queen St**

Length (ft) (m)	12ft 3in 3m 74cm	Width (ft) (m)	1ft 1in 33cm	Height (ft) (m)	6ft 8in 2m 03cm
Height (ft) (m)	Footing	8in 20cm	Mud Work (Exposed)	4ft 6in 1m 37cm	Coping 1ft 6in 46cm
Condition	Good. Coping requires attention.				
Comments	Vegetation should be removed.

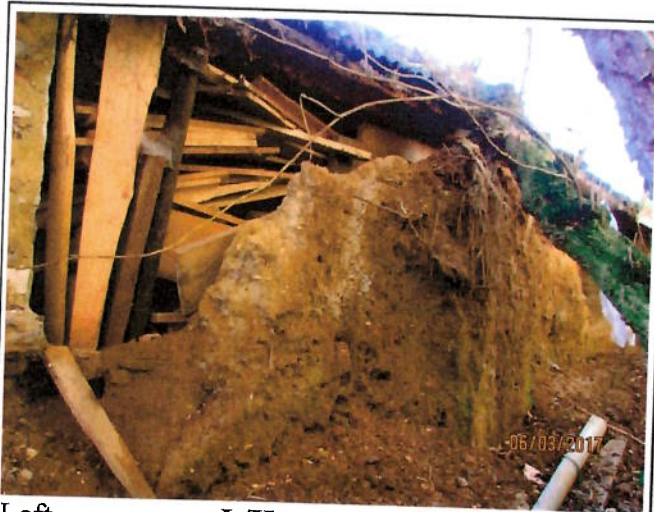
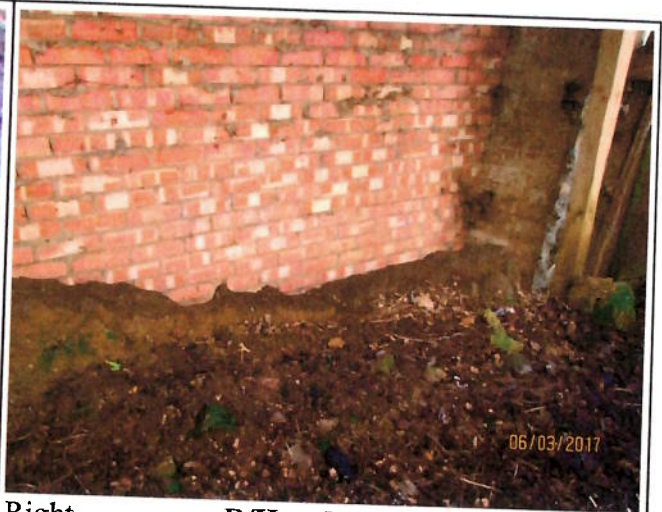
Location **Black Bull Public House / Former Cinema**

Length (ft) (m)	20ft 6m 10cm	Width (ft) (m)	1ft 3in 38cm	Height (ft) (m)	6ft 6in - 2ft 1m 98cm - 61cm
Height (ft) (m)	Footing	Not visible	Mud Work	2ft 61cm	Coping Nil
Condition	Very poor.				
Comments	Soil level high - mud from collapsed wall. We welcome the planned restoration.

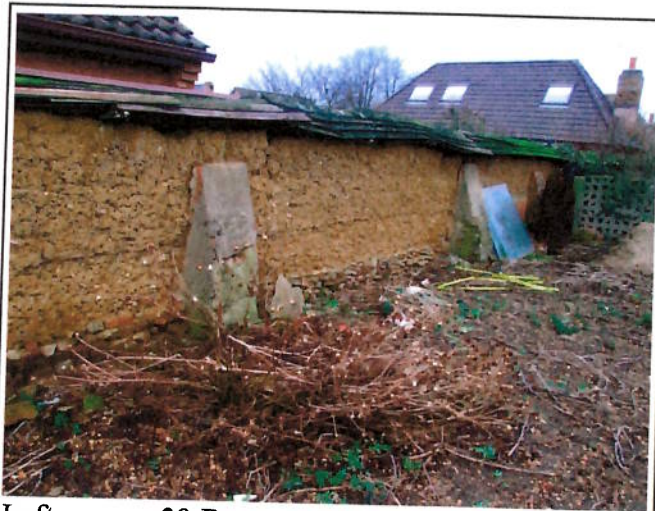
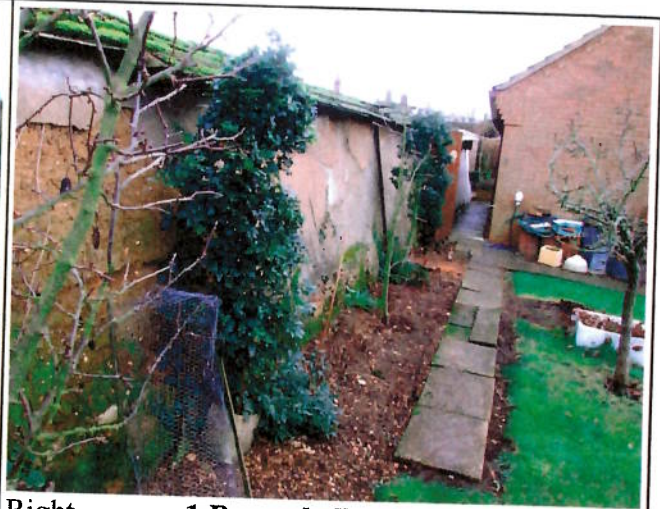
30 Bassenhally Rd / 1 Bassenhally Court

Length (ft) (m)	71ft 21m 65cm	Width (ft) (m)	1ft 2in 36cm	Height (ft) (m)	6ft 6in 1m 98cm	
Height (ft) (m)	Footing	1ft 5in 43cm	Mud Work (Rendered)	4ft 4in 1m 32cm	Coping	11in - 1ft 2in 28cm - 36cm
Condition	Average. Cement render lifting off in places. Some emulsion paint used. Damage to end of wall.					
Comments	Attention required to wooden coping. Some coping replaced by slates.

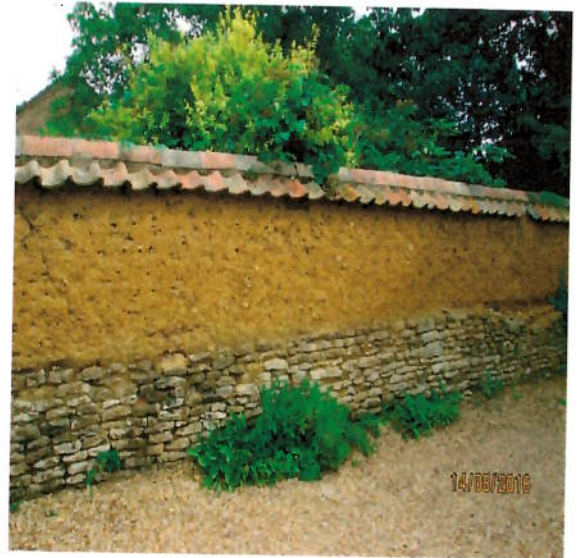
Picture 2

Picture 2, shows a fine section of wall, except for the missing tile at the far end, causing damage to the mud wall and footings by erosion.
